IN RE: NEW ENGLAND COMPOUNDING PHARMACY, INC.
PRODUCTS LIABILITY LITIGATION

AFFIDAVIT OF JEFFREY ERICKSON

PHOTOGRAPHS FROM JULY 9, 2014 SITE INSPECTION

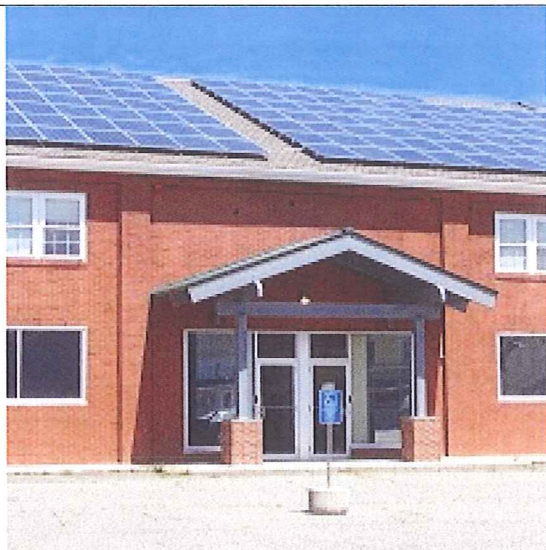
21. When I returned to the Facility on July 9, 2014, I observed that solar panels had been installed on the entire south face of the peaked roof on the south side of the NECC Facility. *See* Figure 1, p. 16. Those panels are not over the 2006 or 2008 Cleanrooms. In fact, the solar panels are over a mezzanine area which is separated in the interior by a wall from both the 2006 and 2008 Cleanrooms. No solar panels were in place at the time the 2008 Cleanroom was completed in mid-2008.

Figure 1 - INSTALLATION OF SOLAR PANELS

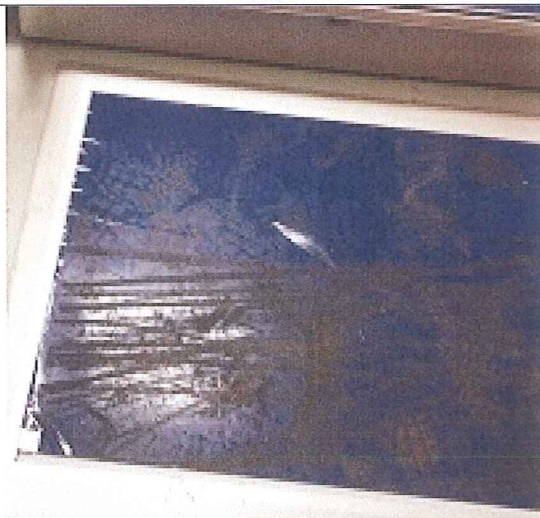
- b. Filthy unchanged “sticky mats” in several areas of the rooms. *See e.g.* Figures 2 and 3, p.16;
 - c. Unsanitary autoclave. *See* Figure 11, p. 17;

Figure 2 - FILTHY STICKY MATS

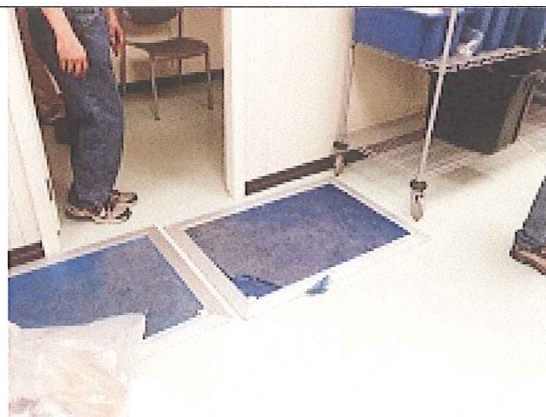
Figure 3 - FILTHY STICKY MATS

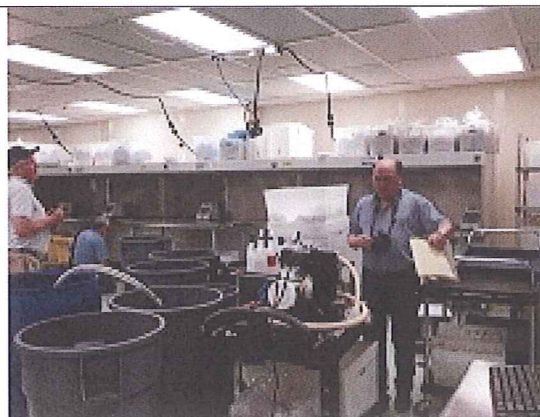
- All of the rooms have cameras, installed by NECC and/or Ameridose or its contractors, mounted on the walls, near the ceiling, with exposed wiring penetrating ceiling tiles without any visible caulking on the cleanroom side, giving the opportunity for foreign matter and contaminants to travel into the cleanrooms;

- c. Same potential as (b) above for the cart Pass-Thrus;
- d. Not properly sealing penetrations into the room, such as plumbing, cameras, electrical, *etc.*, results in an inability to maintain room pressures;

Figure 4 - CEILING PENETRATIONS

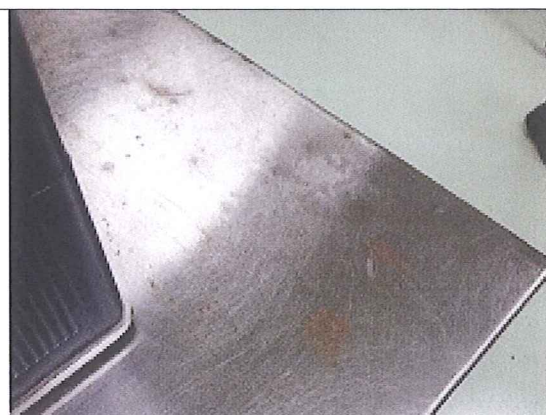
- f. Rust on several doors, walls, processing equipment. *See e.g.* Figure 5, p.16;
- The Stanley sliding door leading into the Preparation Room for the 2006 Cleanroom was not working. It had damaged and missing gaskets. *See e.g.* Figure 10, p. 17;

Figure 5 - RUST ON PROCESSING EQUIPMENT

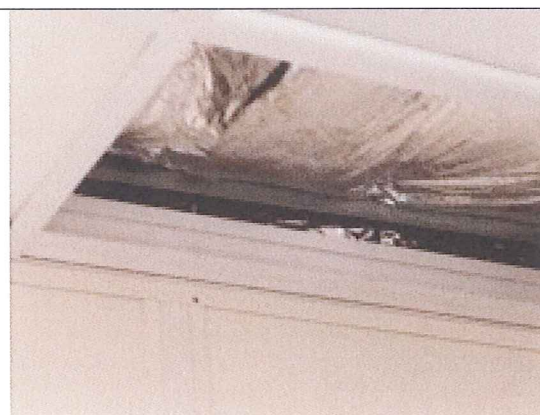
- Some ceiling tiles showed water damage and some ceiling tiles were missing. *See e.g.* Figure 6, p. 16 and Figure 12, p. 17;
- Exposed ductwork had visible water damage to the fiberglass insulation;

Figure 6 - MISSING CEILING TILE

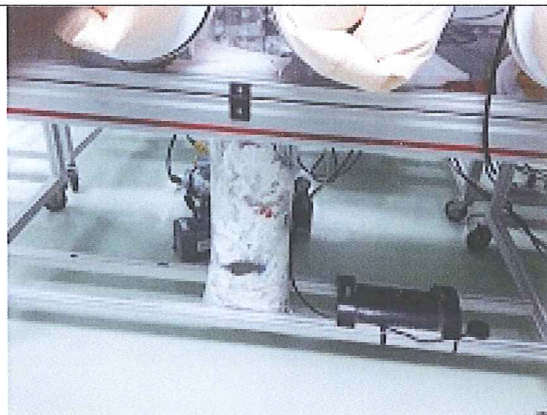
- d. Holes in the main roof that allowed light to show through. *See e.g.* Figure 16, p. 18;
 - e. Full and overflowing garbage receptacles in and around the cleanroom as well as several of the production units. *See e.g.* Figure 7, p.17 and Figure 15, p.18;

Figure 7 - FULL GARBAGE BAG AT PROCESSING EQUIPMENT

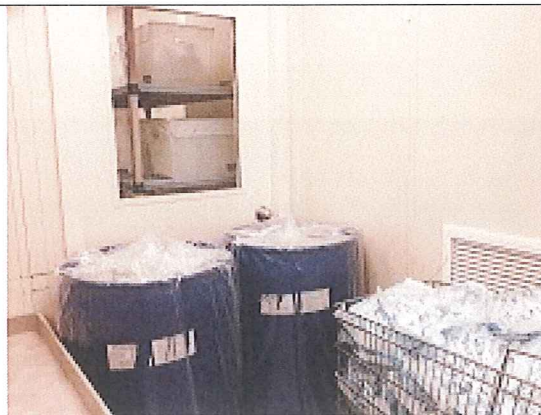
- There are low wall air return grilles in the walls of both of the cleanrooms. Of these, some were so blocked that they were almost impossible to see, many were totally blocked and all were, at least, partially blocked. *See e.g.* Figure 8, p.17;

- a. The purpose of return grilles is to allow for the air to pass through the grilles to the HVAC system and then to the HEPA filters. With the grilles blocked, the passage of air is prevented, allowing potential contaminants to accumulate on the items placed in front of the grilles;

Figure 8 - EXAMPLE OF BLOCKED RETURN GRILLES

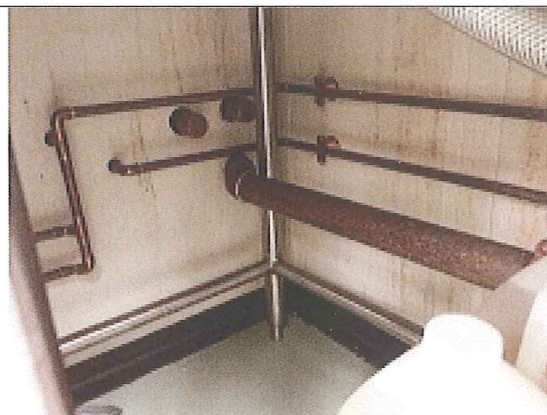
- All plumbing pipe installations made by NECC and/or Ameridose or its contractors that penetrated the walls were not sealed and had no escutcheon plates. *See e.g.* Figure 9, p. 17;

Figure 9 - IMPROPER PIPING, RUST

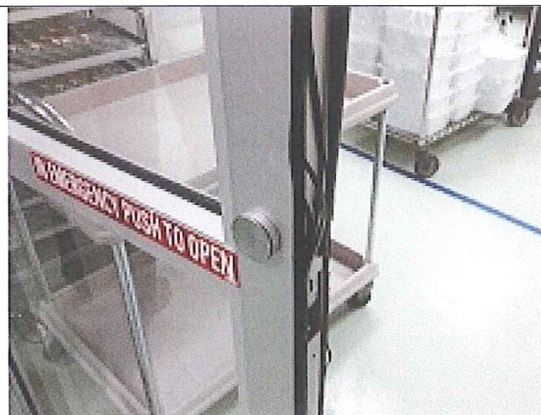
- The Cozzuli filling machine, presumably used to fill vials with compounded preparations, was located in the ISO 7 Preparation Room, and less than ten feet from the inoperative Stanley sliding door, which would have allowed for contamination to migrate into the Preparation Room. It is my understanding that filling machines are normally operated in a room with a lower ISO class, *i.e.* a cleaner environment. In addition, the filling machine was located directly below damaged ceiling tiles;

Figure 10 - INOPERABLE STANLEY DOOR, DAMAGED GASKETING

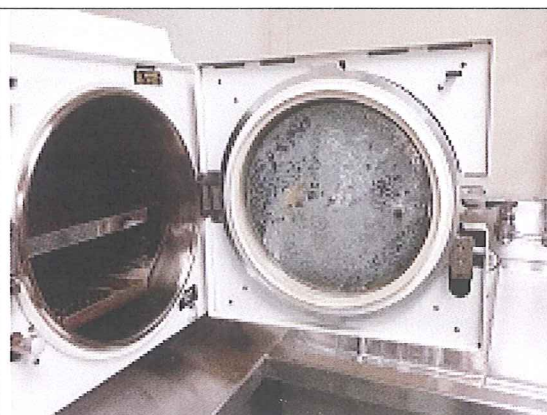
Figure 11 - FILTHY AUTOCLAVE

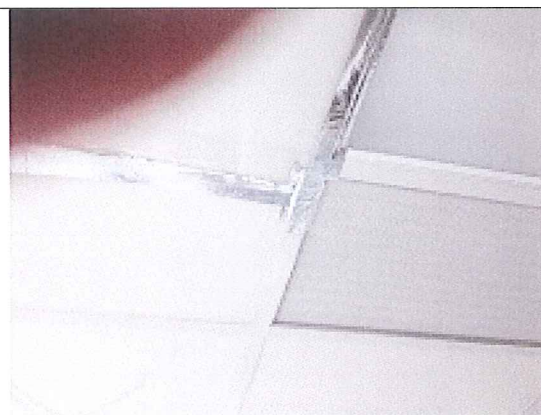
Figure 12 - CEILING TILE

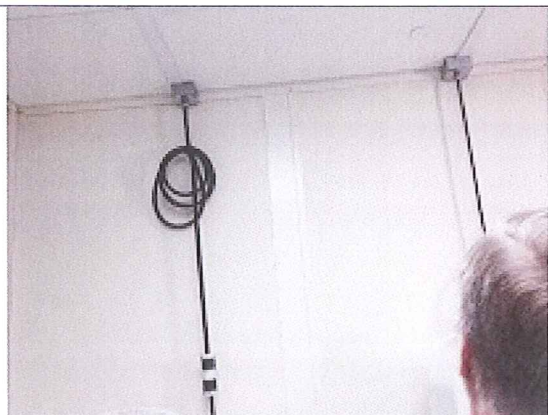
Figure 13 - IMPROPER CEILING PENETRATIONS

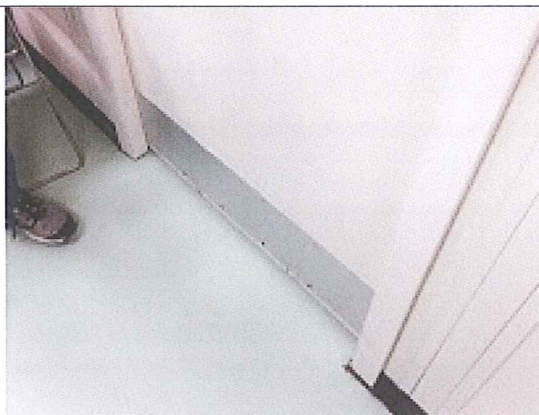
- All but two (2) of the door sweeps that were installed by Liberty had been removed as evidenced by the visible holes exposed in all doors where they had been attached. *See e.g.* Figure 14, p. 18. There were gaps of 5/8" to 3/4" between the floor and the bottoms of the doors;

- b. Removal of the door sweeps makes it extremely difficult to accurately control room pressures and allows for contaminants to enter the room. This condition is even more likely when the HVAC is shut down;

Figure 14 - MISSING DOOR SWEEPS

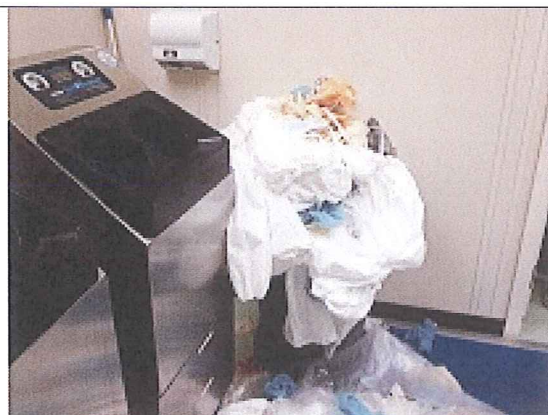
Figure 15 - OVERFLOWING GARBAGE IN THE PROCESSING AREA

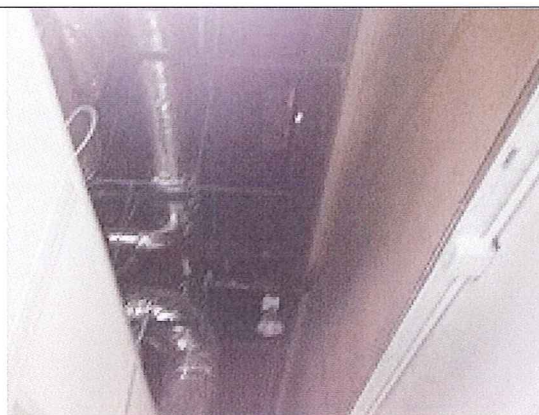
19. At no time after the roof work was completed did I observe any leaks or any evidence of leaks. However, during the July 9, 2014 site visit, obvious roof repairs were seen over and above the 2006 and 2008 cleanrooms. *See* Figure 18, p. 18. Holes in the exterior ceiling permitted daylight to shine into the Facility. *See e.g.* Figure 16, p. 18.

Figure 16 - HOLE IN EXTERIOR ROOF WHERE DAYLIGHT SHOWS THROUGH

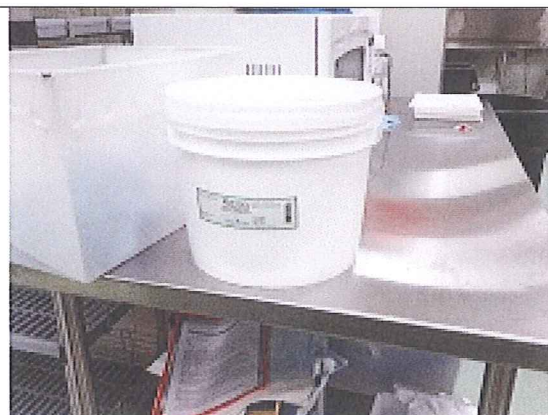
14. During the inspection on July 9, 2014, I observed a one kilogram container of MPA on a counter in the main room of the 2006 Cleanroom. *See e.g.* Figure 17, p.18. I observed MPA nowhere else in the NECC Facility during that visit. This would suggest that the MPA was produced in the 2006 cleanroom. However, Liberty has no direct knowledge of compound(s) manufactured by NECC within the three cleanrooms.

Figure 17 - CONTAINER OF MPA FOUND IN THE 2006 CLEANROOM

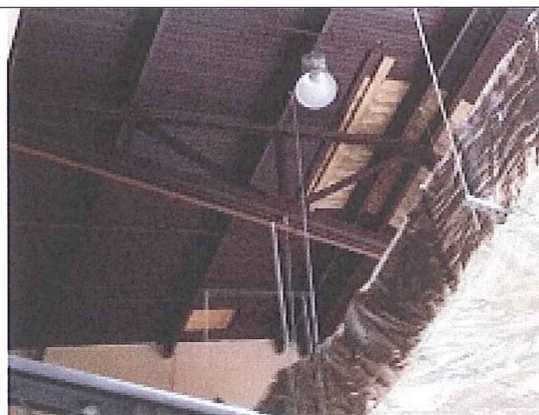
Figure 18 - EVIDENCE OF EXTERIOR ROOF REPAIRS OVER THE CLEANROOM
